<p align="center">NETWORK RAIL</p> <p align="center">VISUAL EXAMINATION REPORT</p>

ELR: ECM1	Mileage: 041m 0286yds 13ch	Railway ID:110A

Asset Name:	Station Footbridge - Biggleswade	Asset Type:	Footbridge
Route:	London North Eastern	Area:	Kings Cross
Post Code:	SG18 8LL	OS Ref:	TL 19270 44358
Primary Material:	RBE - Steel	Secondary Material:	NO SECONDARY MATERIAL
Carrying:	Foot	Over:	Rail

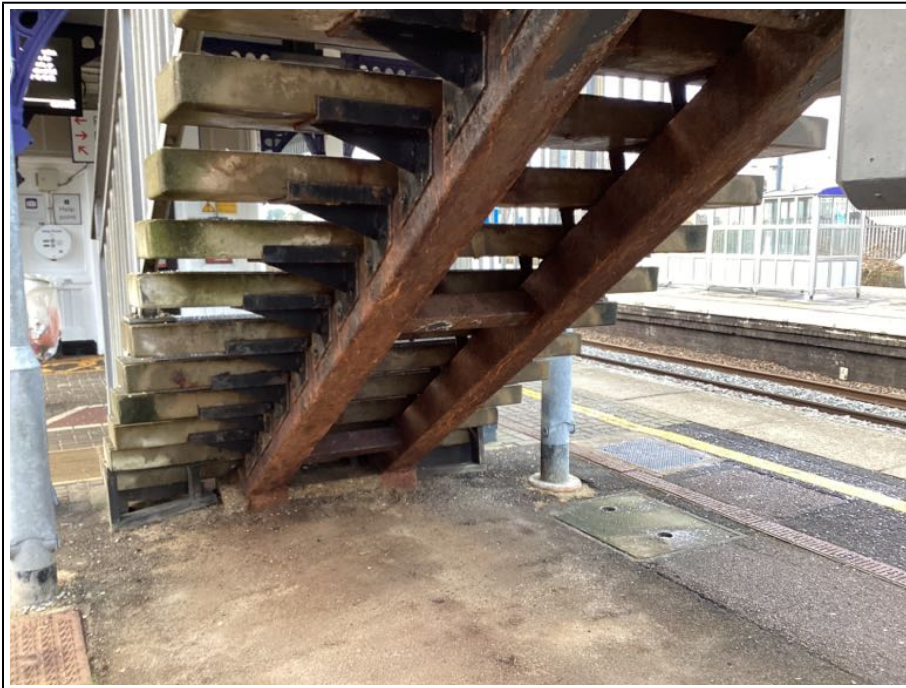
No	Alarm Index No	Exam Date	Access Gained	Defect Quantity	Exam Type	Risk Score	Deterioration	Examiner Comments	Engineer Comments
1 (Open)		General corrosion					Deck soffit support beams various locations.		
1.1		13/01/2024		1		6	New Defect		Defect added to History of Defects Tracker on review of 2024 VExam.

General corrosion throughout main Girders and Staircases see general photos .

General Arrangement Photo 6: General corrosion (13/01/2024)

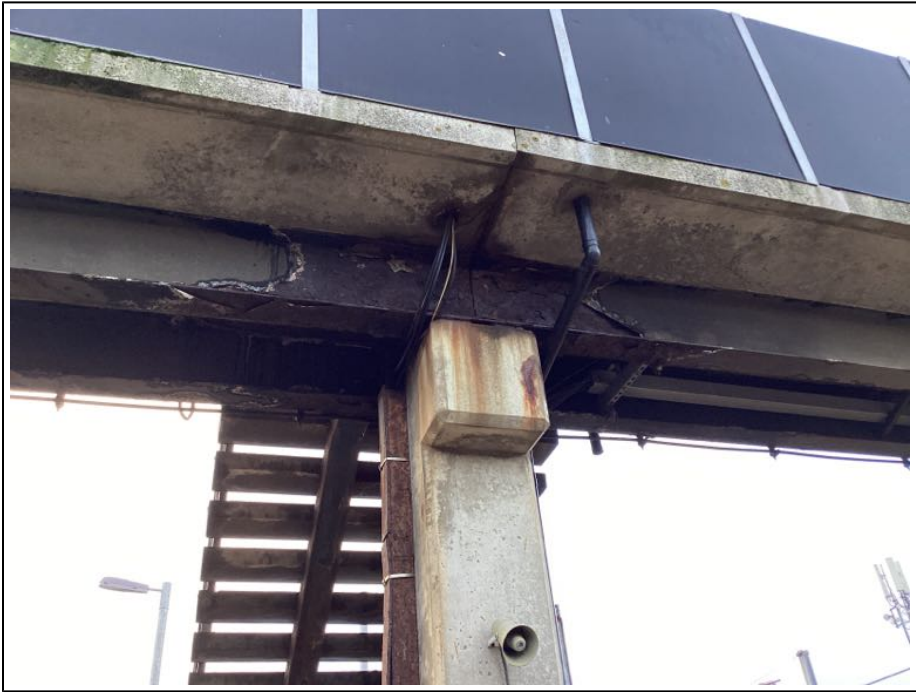
General Arrangement Photo 7: General corrosion (13/01/2024)
