# RECORD OF SITE VISIT

<b>JNP GROUP</b> <small>CONSULTING ENGINEERS</small>  <a href="http://www.jnpgroup.co.uk">www.jnpgroup.co.uk</a>	Site	MEC8445 - Biggleswade Station
	Footbridge	
	Client	AMCO.GIFFEN
	Job No	S12375
Date Of Inspection	15 February 2024	Time 10.0 am
Weather	Mild and dry

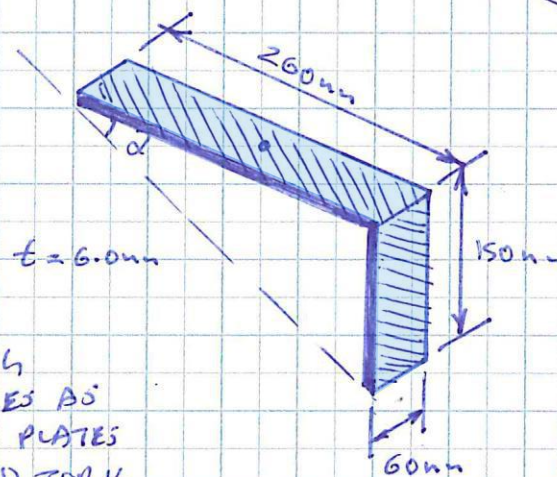
EXISTING CONCRETE STEPS  
SUPPORTING DETAILS.

THE EXISTING STEEL BRACKES AS BENT STEEL PLATES ARE WELDED TOP & BOTTOM TO 180x180 SHS AND BOLTED ON TOP TO CONCRETE STEPS.

EXISTING 6.0mm THICK 260mm LONG 60mm WIDE 150mm DEEP BENT STEEL PLATES SUPPORTING CONCRETE STEPS ABOVE EACH OF (180x180) SHS STEEL BEAMS

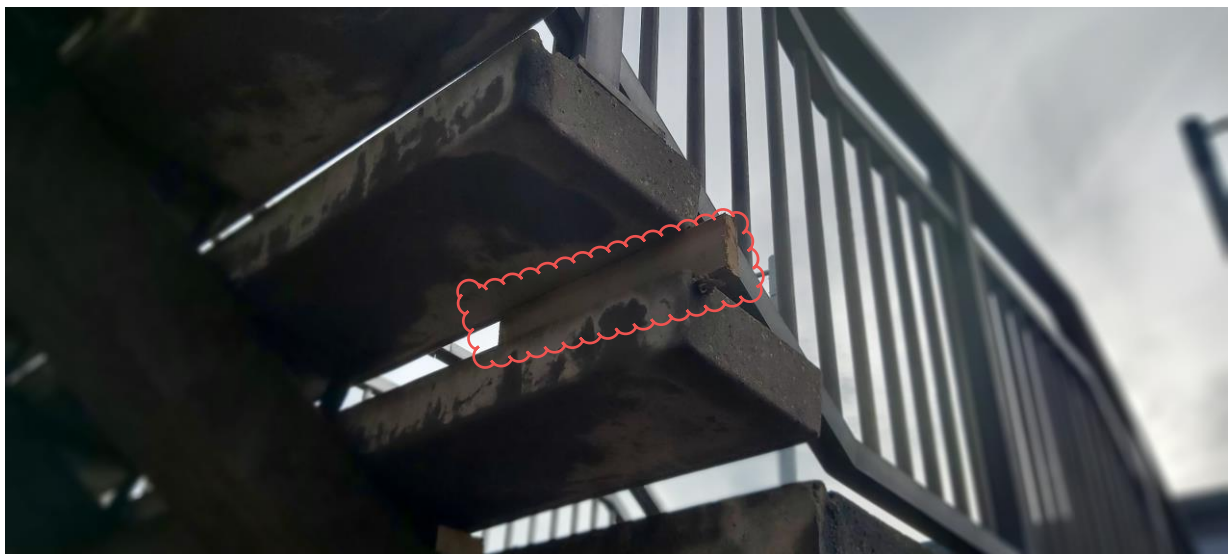
This concrete step was temporarily supported by three pieces of wood. These pieces were placed between the front edge of the step and the back of the next step below it to prop the front edge of the step and prevent it from dropping as a temporary measure.

There was no immediate risk of this step falling and the concrete treads are stable in the temporary condition with the pieces of wood placed one at each end and one at the middle of the step.

F10  
Temporary timber support under the front edge of  
the concrete step

Temporary support to steps is to be provided by using timber sections with similar details to that already in place for the failed step. Please refer to photograph F10 at the back of this report.

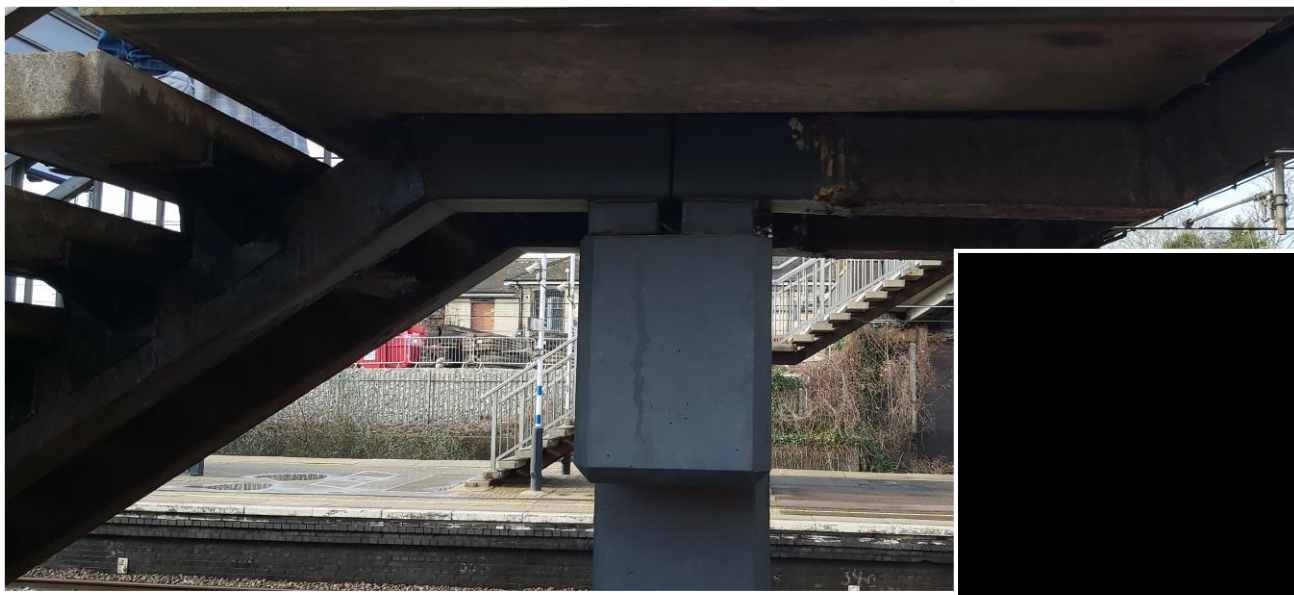
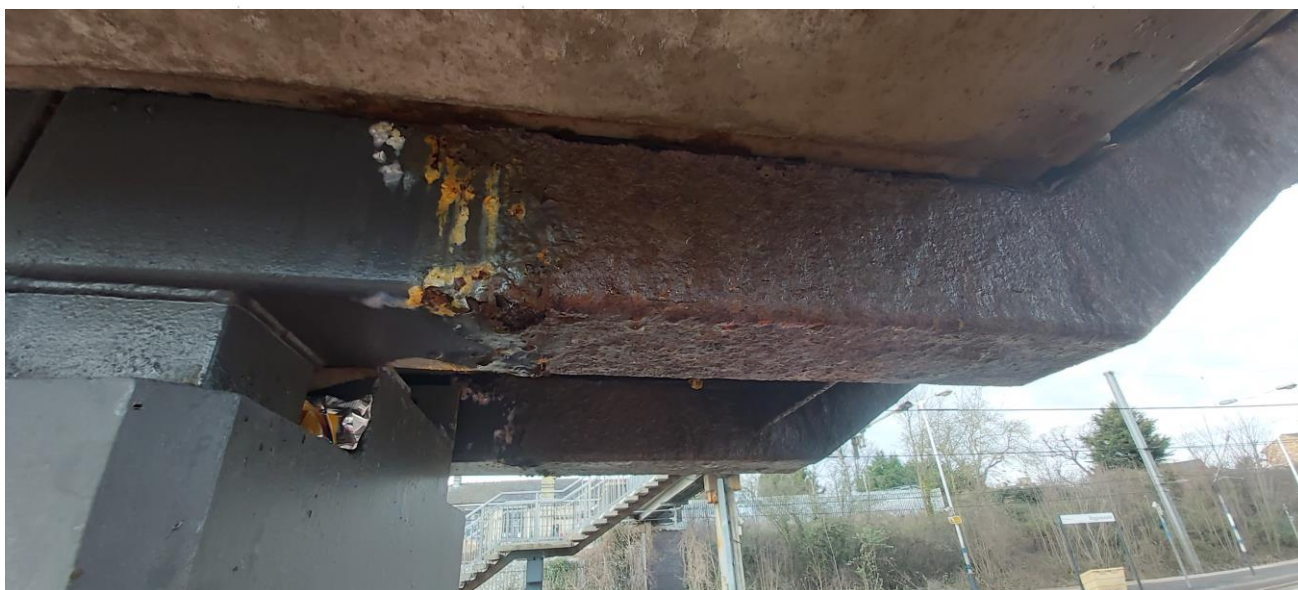
F11 above & F12 below

Where steel sections were sheltered and away from the effects of water runoff, there were no noticeable signs of corrosion. Please refer to photographs on page P9 and P10 at the back of this report.

Central landing concrete "T" column support showing bearings to Platforms 1&2 with sheltered parts of 180x180 SHS protected from corrosion and the exposed parts corroded

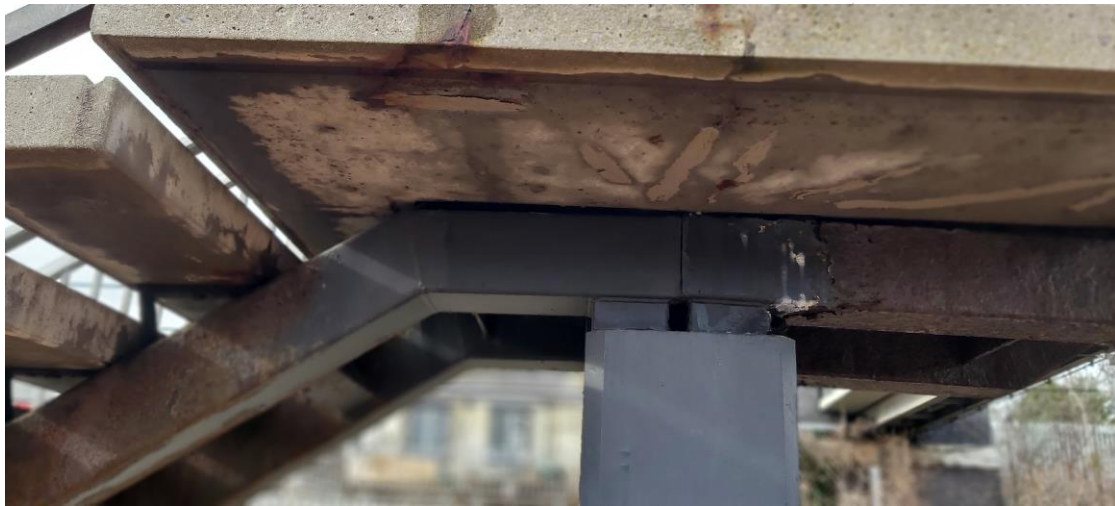
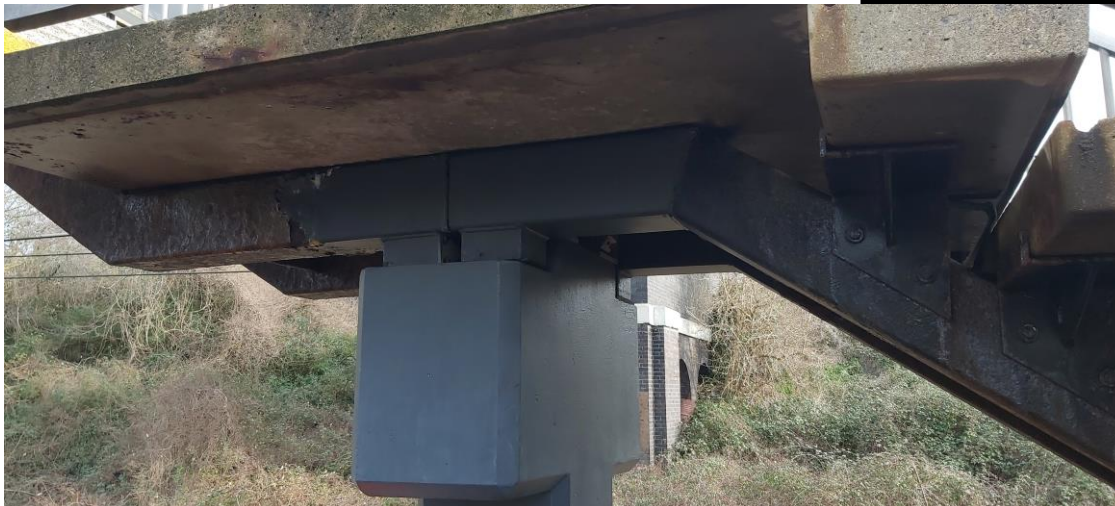
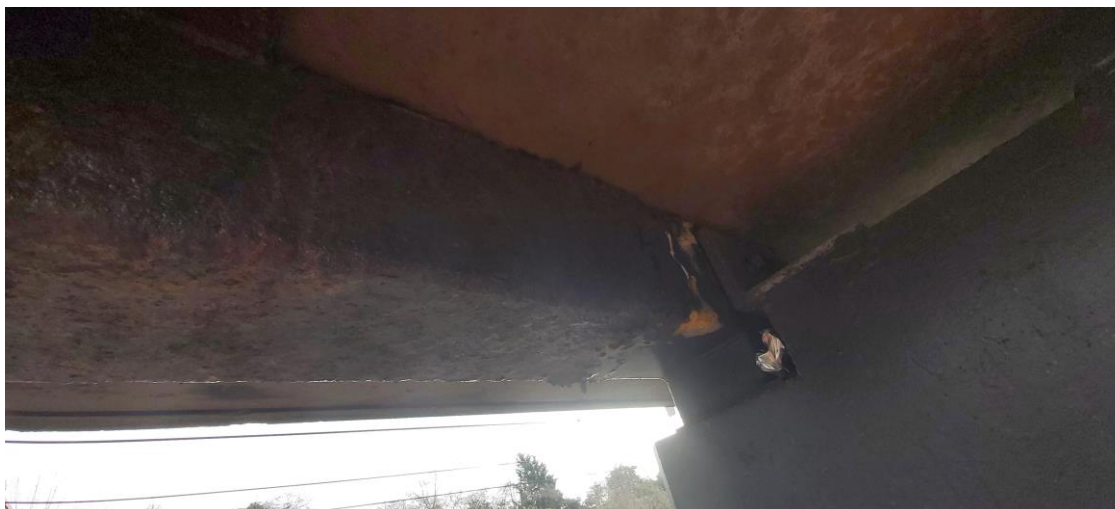
F13, F14 & F15

It is apparent that the corrosion is a combination of exposure to the external environment and their general arrangement, with corrosion noted in locations exposed and vulnerable to water runoff from the treads.

The water run off most probably contains de-icing salts at certain times of the year making it even more corrosive than purely water alone. This has caused extensive corrosion. Please refer to photographs on page P11 to P14 at the back of this report.

180X180 SHS sections supported at central column position  
on Platform 1&2 showing corrosion to parts not sheltered

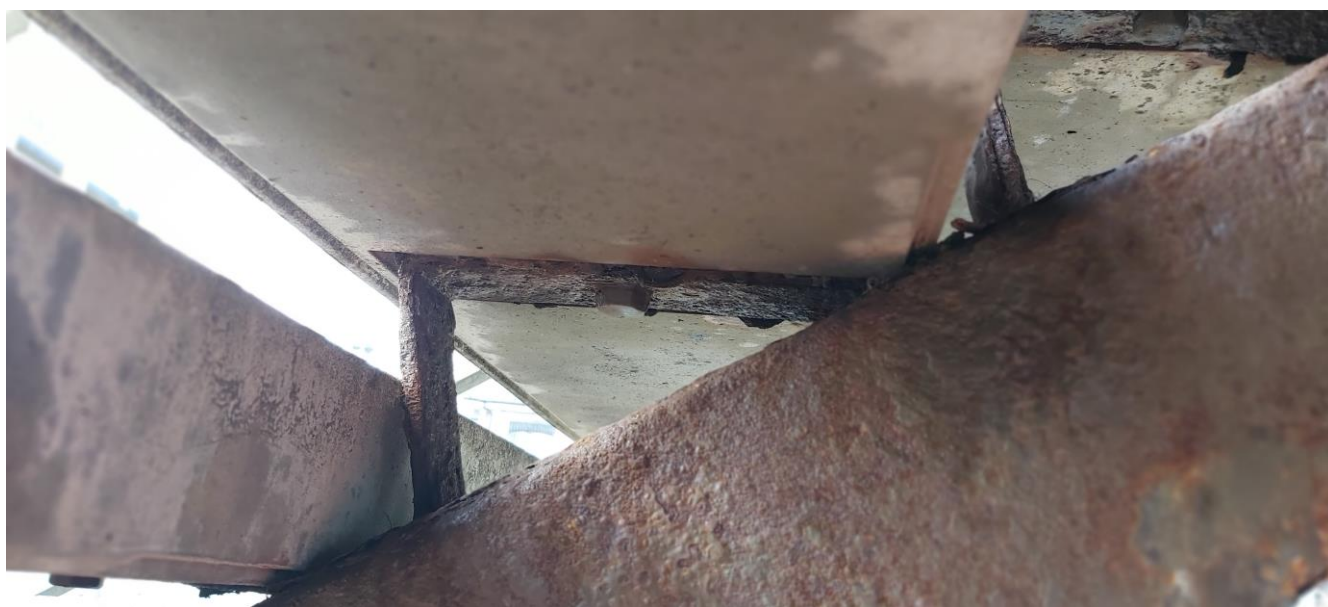
**F16**

One of the single bent steel plate brackets supporting one of the concrete steps above the twin cranked SHS beam sections had given way due to extensive corrosion.

Almost all of the existing "L" shaped brackets providing primary support of the tread off the twin cranked steels were badly corroded. Please refer to photograph F16 at the back of this report.

A typical view of the badly corroded "L" shaped steel bent plate connected to concrete step soffit with a single bolt and welded to 180x180 SHS section at the top and bottom

A permanent solution to support concrete treads, is to provide new steel shoe brackets like those already on site but for all concrete treads that do not already have steel shoe brackets. Please refer to the structural details provided on page P3 to P5 at the back of this report.

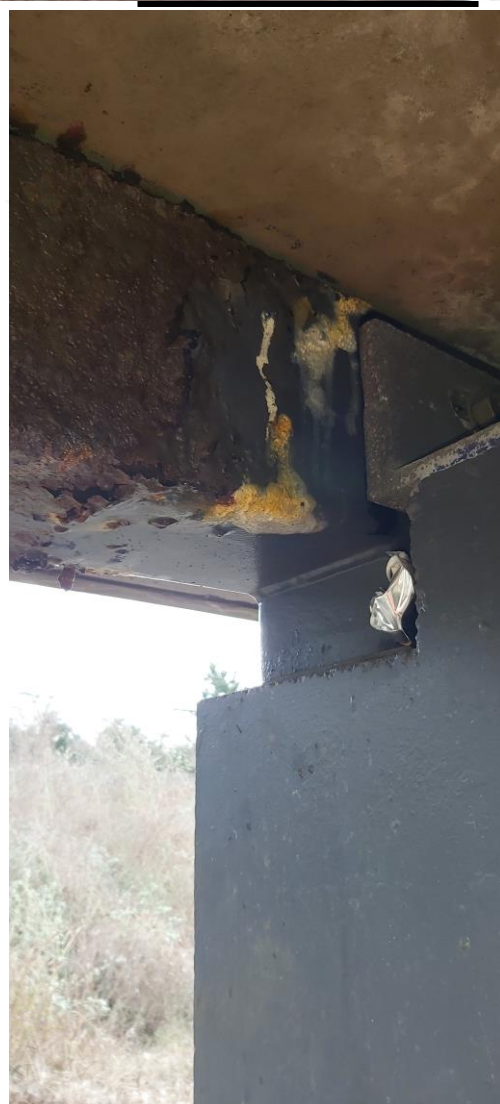
**F17**

180X180 SHS section supported at central column position on Platform 1&2 showing corrosion to parts not sheltered

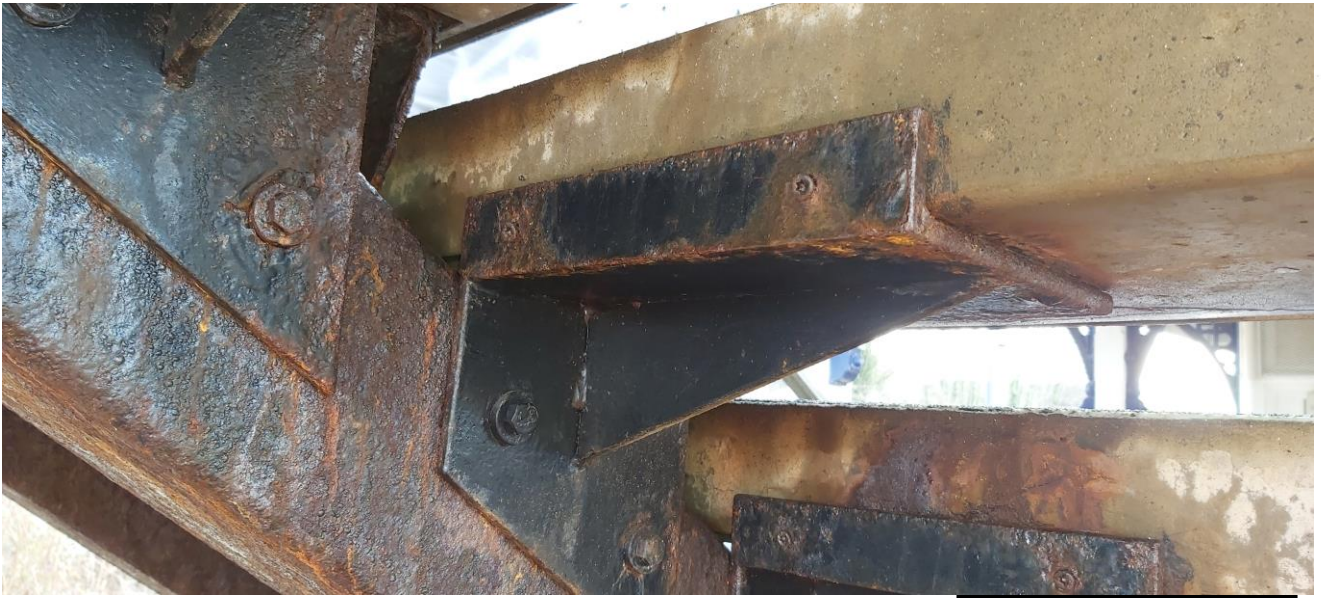
**F18**

The shoe brackets considered implemented as remedial work to some but not all tread locations, offer extended bearing and offer enhanced stability to the treads. If the existing "L" shaped elements supporting the treads failed due to progressive corrosion, the new shoe brackets would act to support the treads. Please refer to the structural details provided on page P2 and photograph F16 at the back of this report.

A typical view of the more recently added partly corroded steel brackets for enhanced support to the existing concrete steps bolted to the external face of each of 180x180 SHS sections.

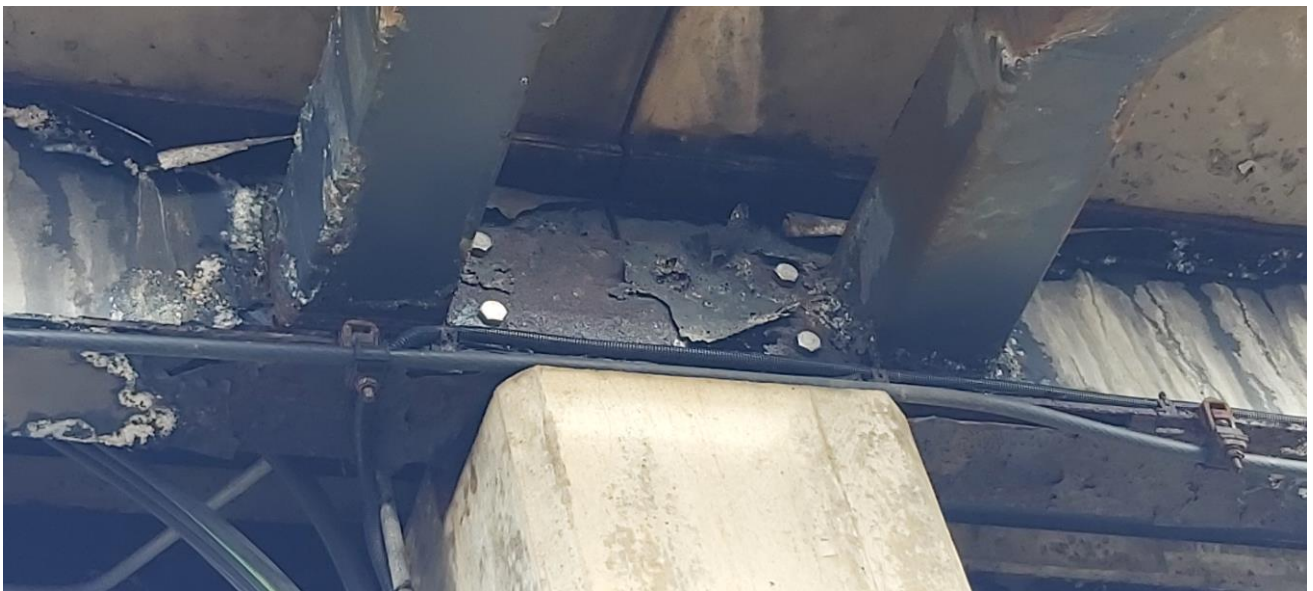
**F19**

A view showing corroded 180x180 SHS section connections at the top of the stairs to the footbridge beams where the joint in the concrete bridge deck above the concrete column support has leaked and has caused corrosion.

All steelwork supporting the stairs is to be cleaned of rust and protective coating applied, a maintenance schedule is then to be implemented to include intermediate inspections between scheduled protective coating repairs based on the manufacturers protective coating guidance.

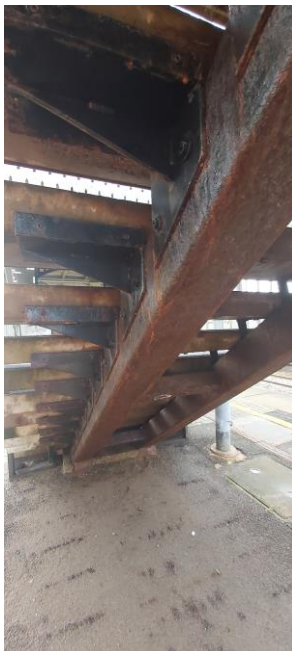
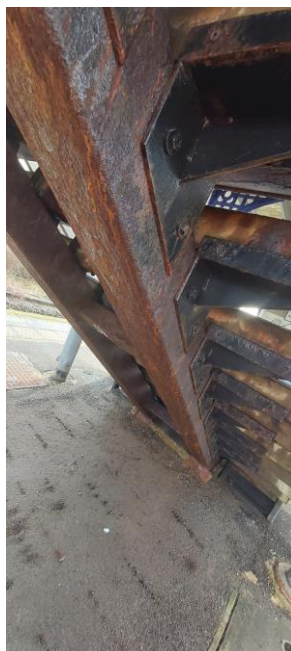
F23 & F24

Views of badly corroded  
180X180 SHS sections with  
steel brackets on Platform  
1&2

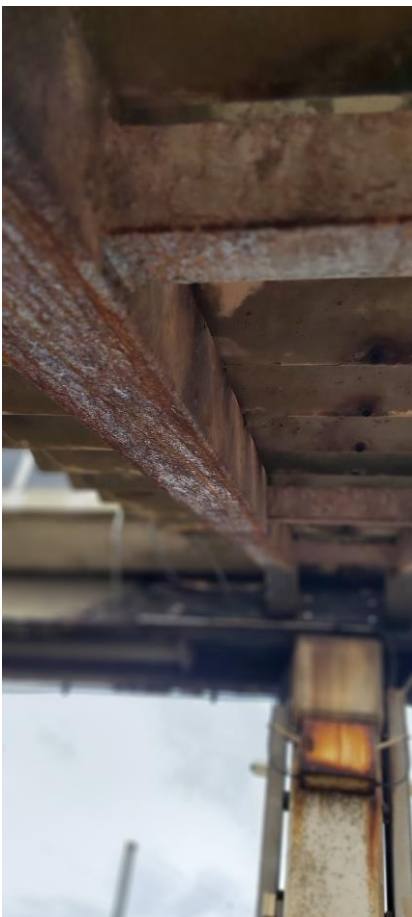
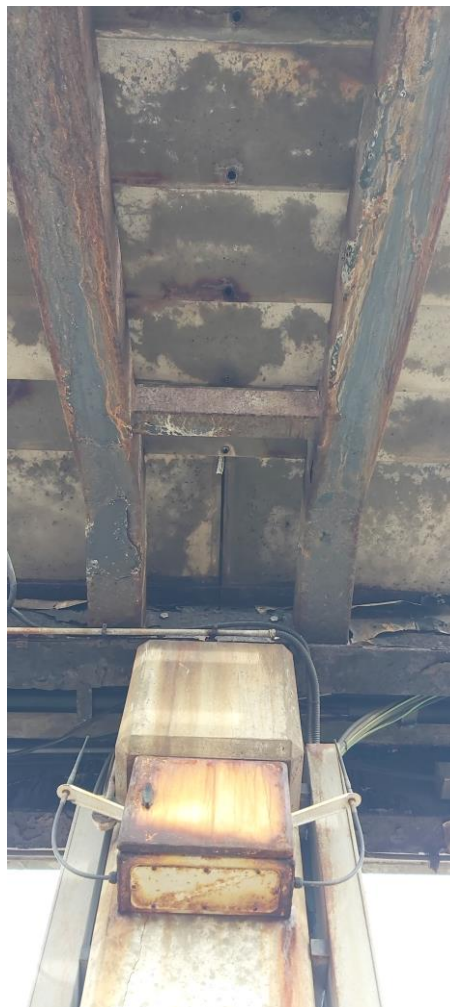
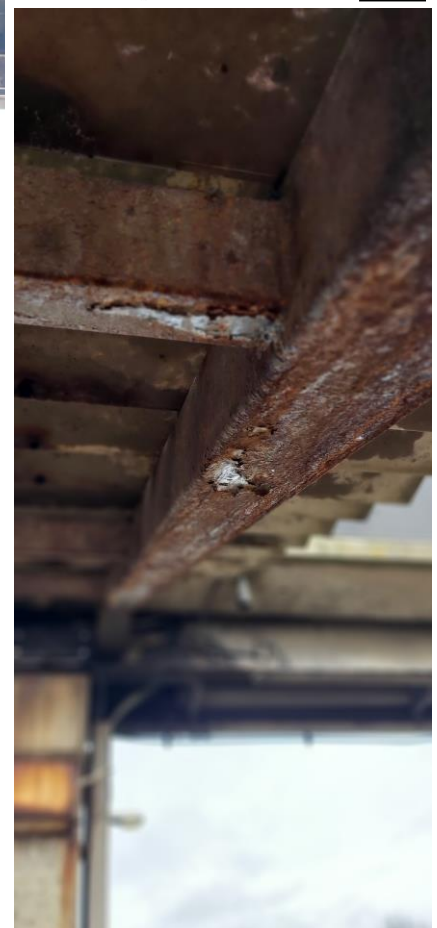
Views of badly  
corroded 180X180  
SHS sections  
above the  
landing for  
stairs on  
Platform 3 & 4
