# Chawston and Wyboston Catchment Investigation

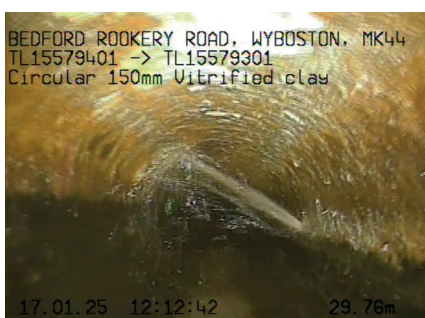
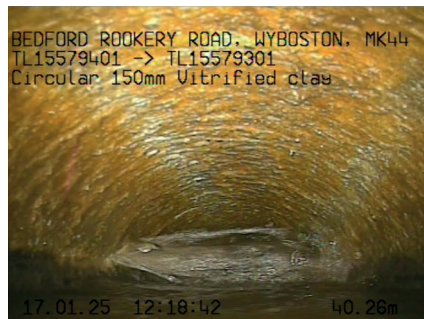
Our journey into the Chawston and Wyboston catchment began after reports of repeated sewer flooding and service disruption. We observed flooding and loss of facilities would persist for weeks following rainfall. This pointed to a strong likelihood that groundwater infiltration, rather than immediate rainfall impact, was contributing to the problem. The behaviour suggested a slow subsidence of groundwater that continued to overwhelm the sewer system long after the rain had stopped.

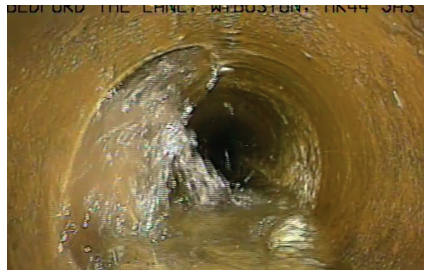
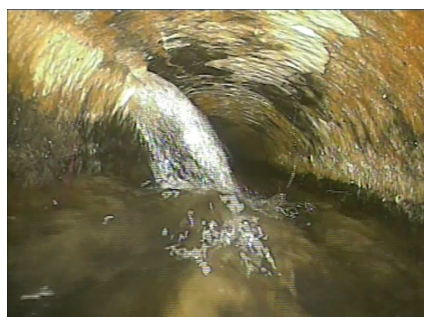
- Rookery Road
- The Lane
- Westfields Road
- Great North Road

Rookery Road emerged as the most significant area of concern. We identified 36 individual points of infiltration in this location alone. These, along with others, were reported to our delivery team for urgent attention.

As part of our rehabilitation strategy to protect Anglian Water assets from groundwater infiltration, we will be relining approximately 2,941 metres of sewer. In addition, associated manhole chambers will be resealed. These works are designed to future-proof the network by significantly reducing the risk of local groundwater entering the foul sewer system, thereby improving resilience and reducing the impact on overall network performance.

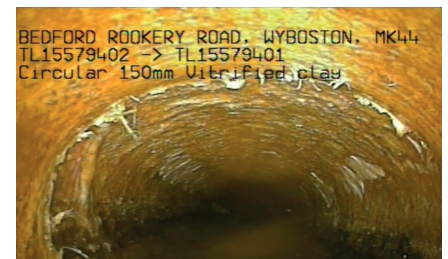
- 10 gushing infiltration points – indicative of major defects or springs
- 48 running infiltration points – moderate, consistent ingress likely from groundwater or faulty joints
- 28 dripping infiltration points – points of small amounts of water ingress
- 20 seeping infiltration points – low-level ingress, common in aging infrastructure

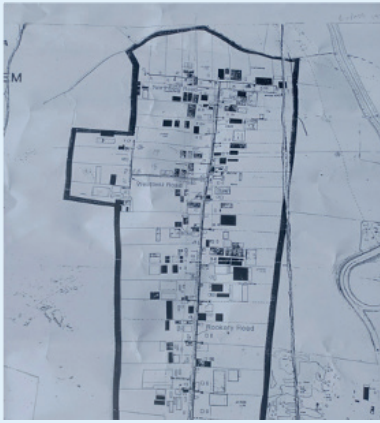
- CCTV inspections revealed significant infiltration in multiple pipe sections along Rookery Road, including gushing infiltration at multiple points throughout sections of Rookery road

One key area we identified was that where previous interventions of lining had been undertaken infiltration was seen to move downstream to sections of the sewer network. This is an example of infiltration entering the network at the end of the patched section of the sewer.

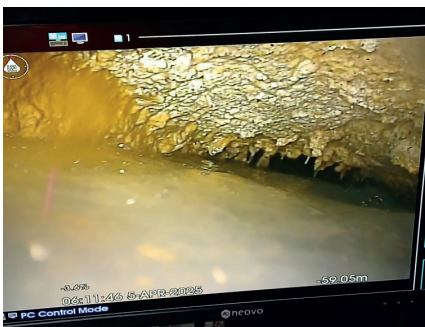
Another issue identified was Fats, Oils, and Grease (FOG) build-up in the sewer network, with the likely source being nearby fast-food establishments. Jetting and cleaning have been recommended, and our Environmental Compliance contractor, ECAS, have been assigned to follow this up. Removing this FOG build up will create capacity in the sewer allowing smoother flow to the Water Recycling Centre (WRC). We're also recommending the installation of monitors to assess the levels/build up of FOG, so we know when interventions need to be undertaken.
