<p align="center">NETWORK RAIL</p> <p align="center">VISUAL EXAMINATION REPORT</p>

ELR: ECM1	Mileage: 041m 0286yds 13ch	Railway ID:110A

Asset Name:	Station Footbridge - Biggleswade	Asset Type:	Footbridge
Route:	London North Eastern	Area:	Kings Cross
Post Code:	SG18 8LL	OS Ref:	TL 19270 44358
Primary Material:	RBE - Steel	Secondary Material:	NO SECONDARY MATERIAL
Carrying:	Foot	Over:	Rail

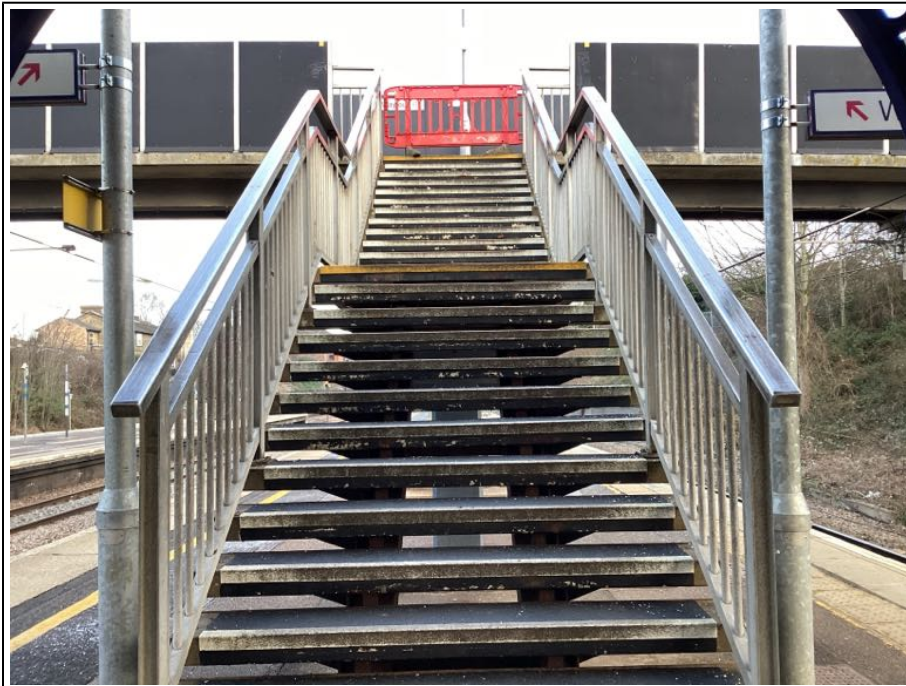
General Arrangement Photo 4: Platform 1/2 Staircase (13/01/2024)

General corrosion throughout main Girders and Staircases see general photos .
